| | TITLE<br>IR-05MBDB Solar Racking System<br>Data Sheet | | | | |

**Subject:** Compression, Horizontal, and Uplift Load Testing on the Universal L Foot Bracket (PN IR-DMLF2000) & IR-T1 No Penetration Tile Roof Bracket (IR-FCTR1500)

# LABORATORY TEST REPORT

Compression Load Test  
Ceramic Tile Roof

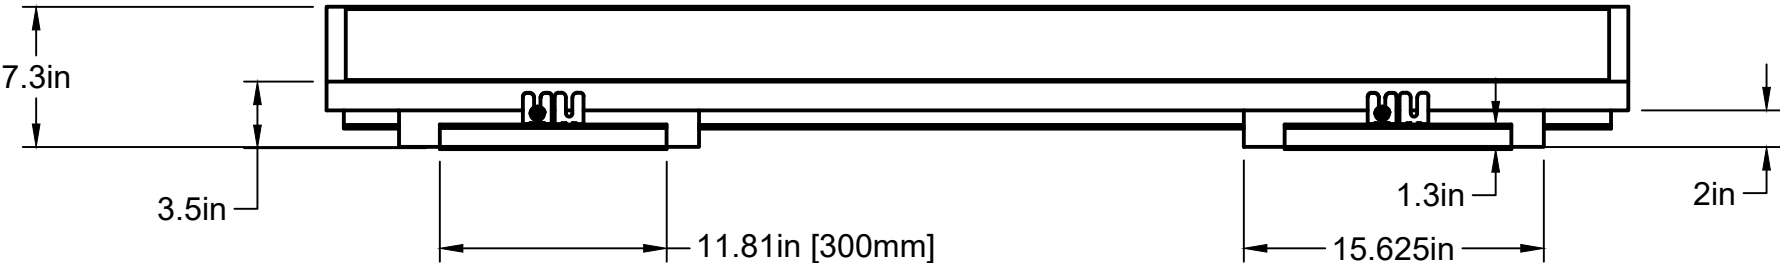
**5 Degree Configuration Dimensions**  
BALLAST BLOCK AND WIND SPOILER CONFIGURATION

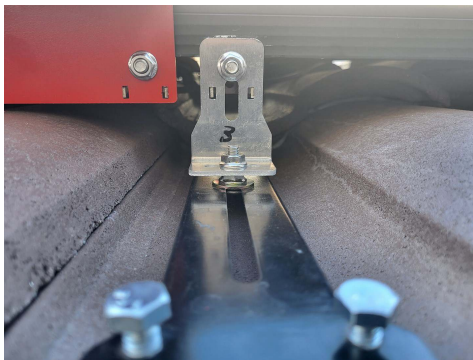
**PHOTO 2:** Typical Bracket - before tests

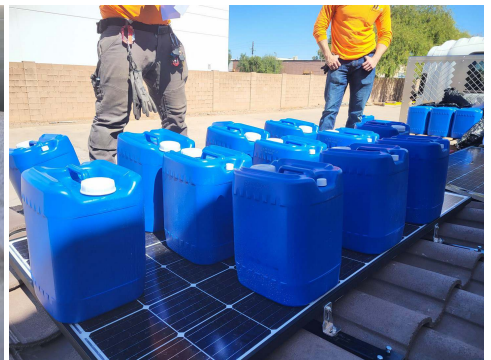
**PHOTO 3:** Load 1

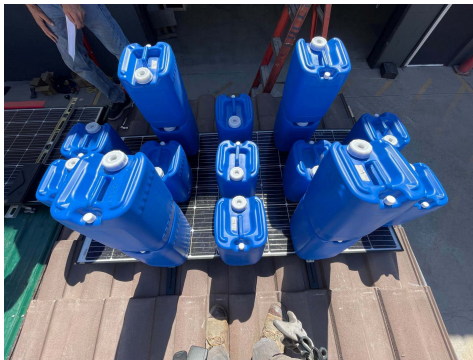
**PHOTO 5:** Load 2

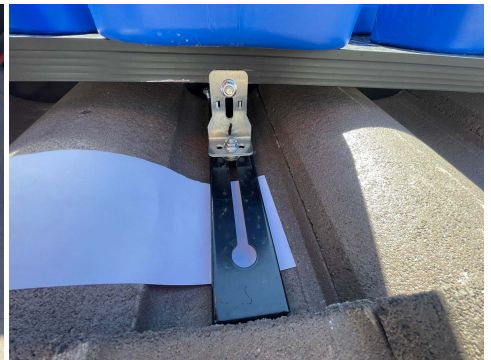
**PHOTO 6:** Load 2 - Bracket under load

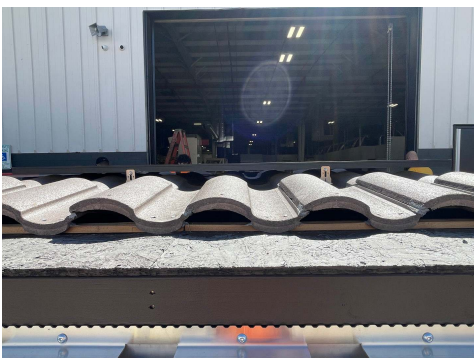
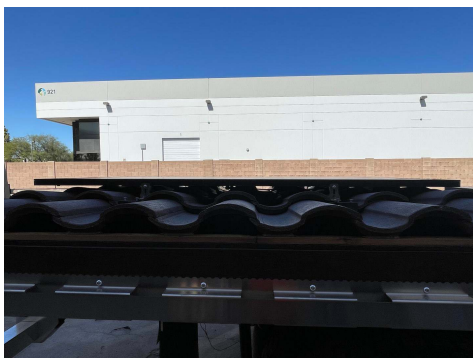
**PHOTO 7:** Unloaded - after tests

**PHOTO 8:** Unloaded - after tests

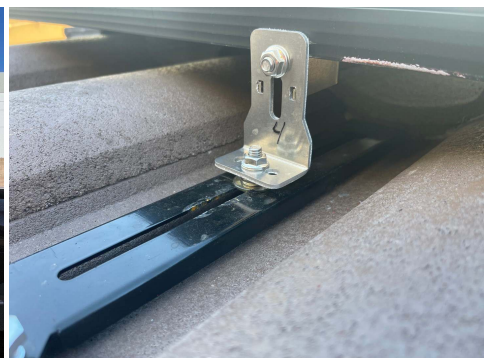
**PHOTO 9:** Unloaded Bracket - after tests

Note: Bracket photos are typical of all locations

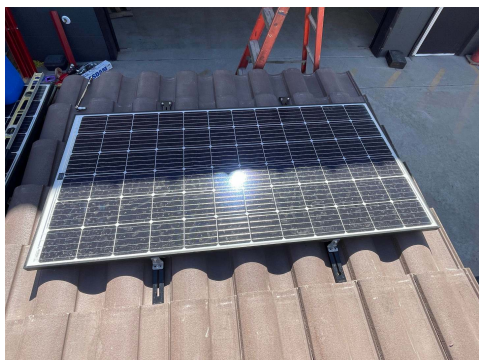
**PHOTO 1:** Overview of solar panel and tile roof deck - before tests

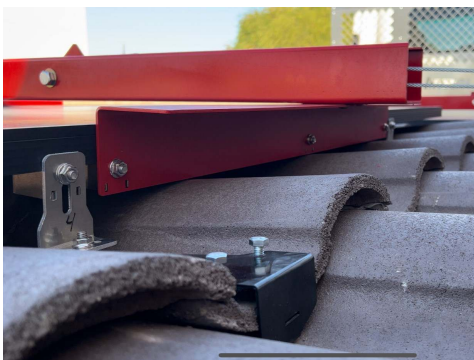
**PHOTO 2:** Bracket with no load

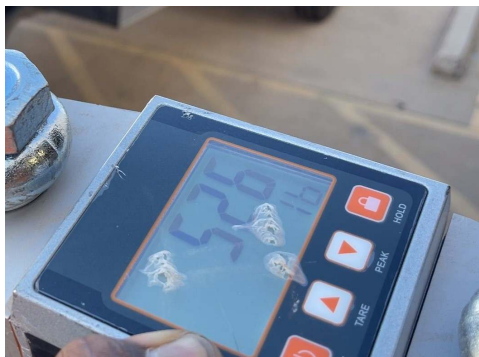
**PHOTO 4:** Applied load

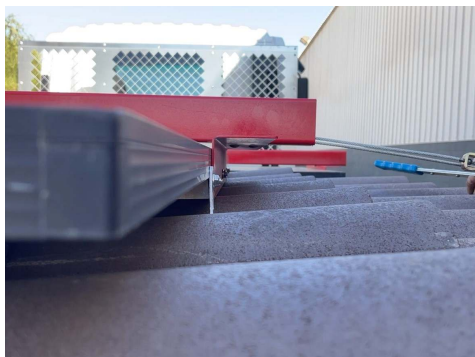
**PHOTO 6:** Test setup after test

| <p>After removal of test load all brackets returned to original position with no permanent deformation noted.</p> <p>The solar panel did not show any signs of permanent damage or deformation.</p> | | | | | | |

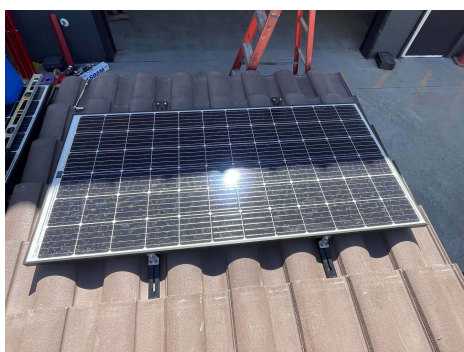
**PHOTO 1:** Overview of solar panel and tile roof deck - before tests

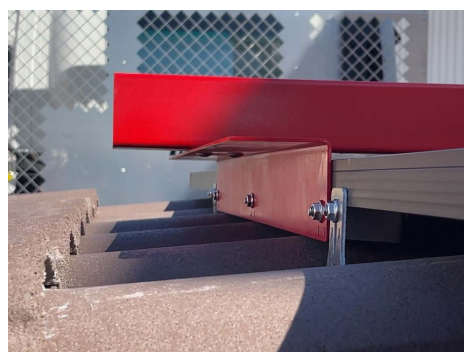
**PHOTO 3:** Brackets with no load

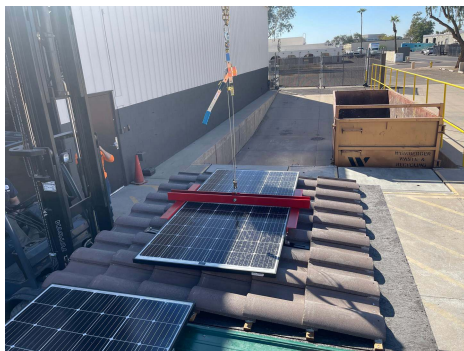
**PHOTO 4:** Test setup

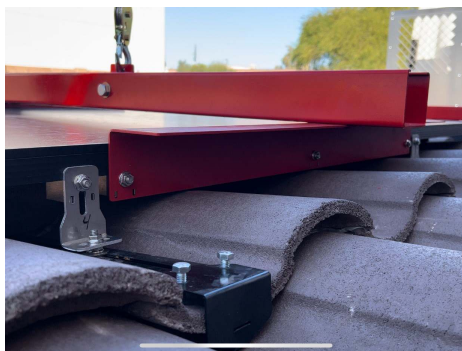
**PHOTO 8:** Bracket unloaded after test

| After removal of the uplift test load all brackets returned to original position with no permanent deformation noted. | | | | | | |
