| | PROJECT<br>IntegraRack | | | |
| | TITLE<br>IR-0BMBDB Solar Racking System Data Sheet | | | |

Subject: Compression, Horizontal, and Uplift Load Testing on the Universal L Foot Bracket (PN IR-DMLF2000) & IR-T1 No Penetration Tile Roof Bracket (IR-FCTR1500)

Compression Load Test  
Ceramic Tile Roof

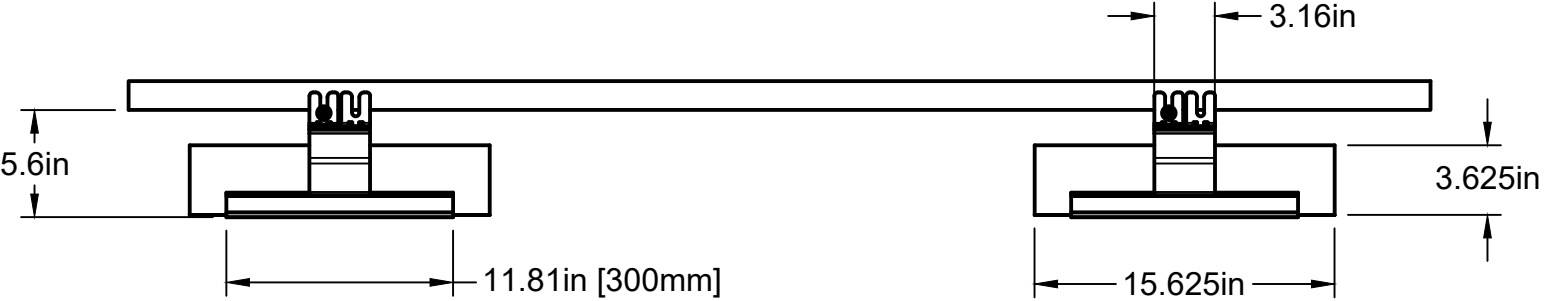
BALLAST CONFIGURATION

Flat Configuration Dimensions

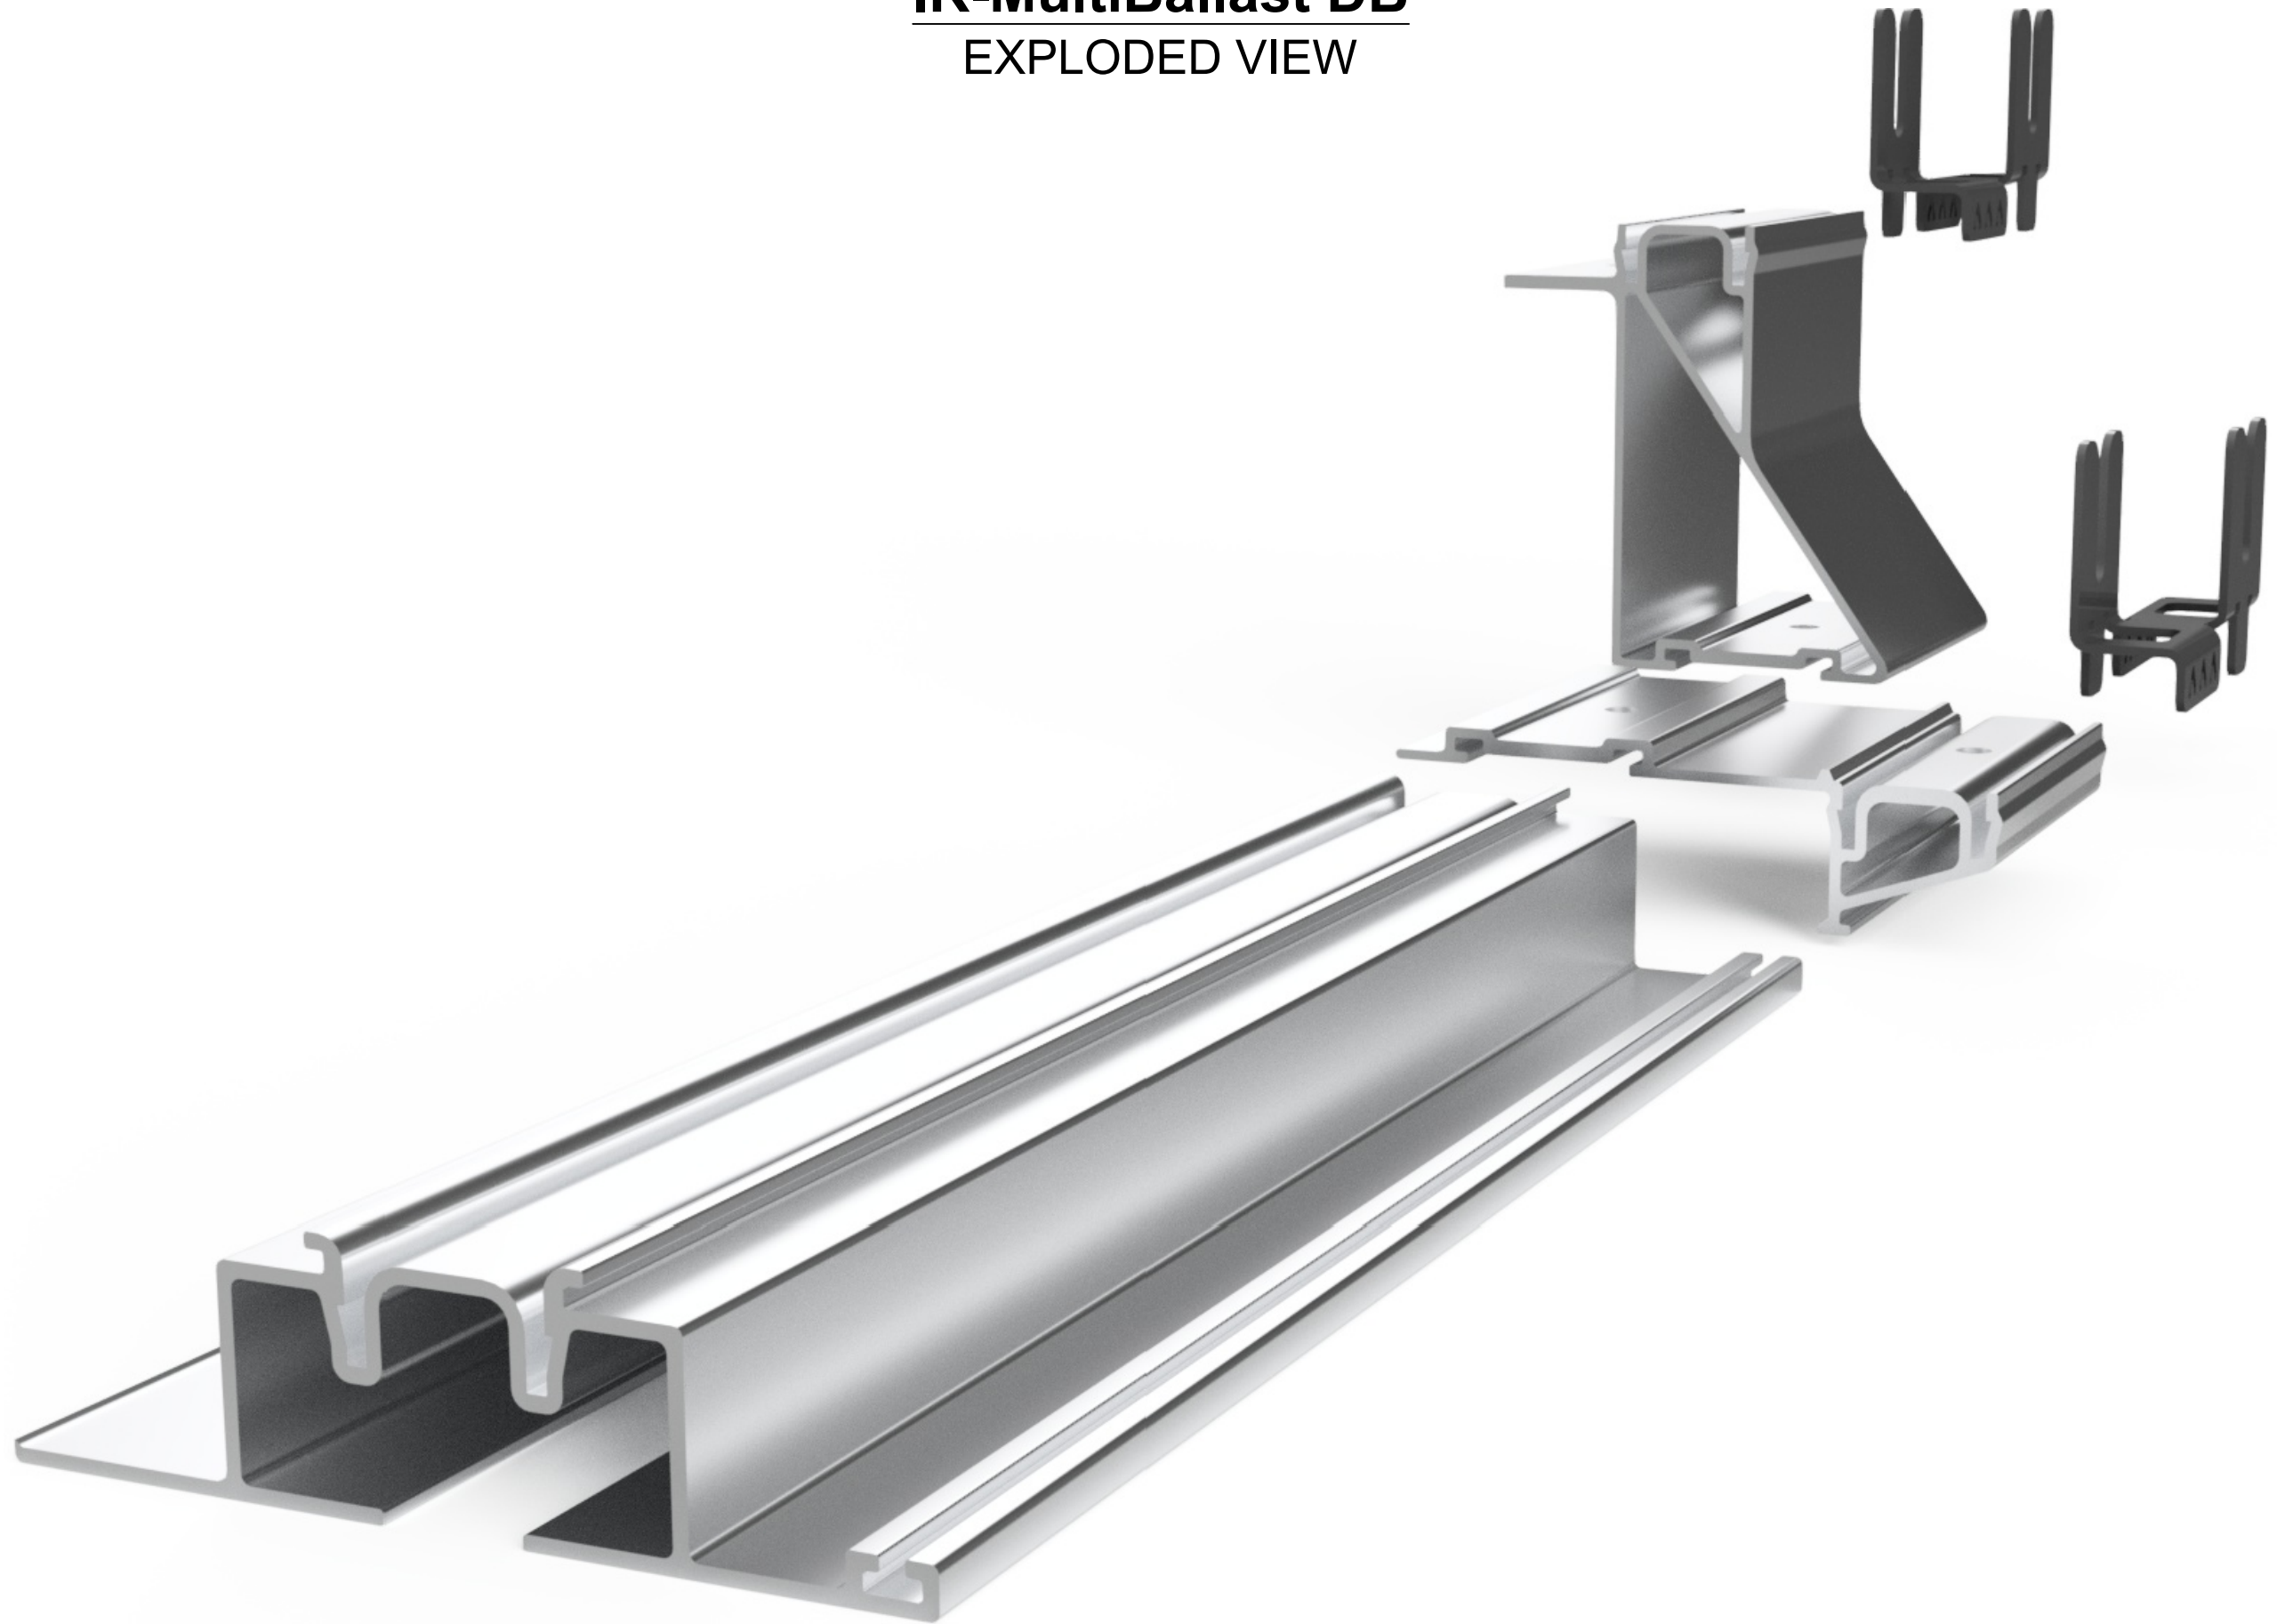
**IR-MultiBallast DB**  
EXPLODED VIEW

- Designed for ballasted deployment of solar modules on flat roofs or flat ground scenarios.
- Utilizes standard 32lb 4in x 8in x16in CMU cinder blocks.
- Roof material slip sheets (9in x 6in) recommended underneath each base.

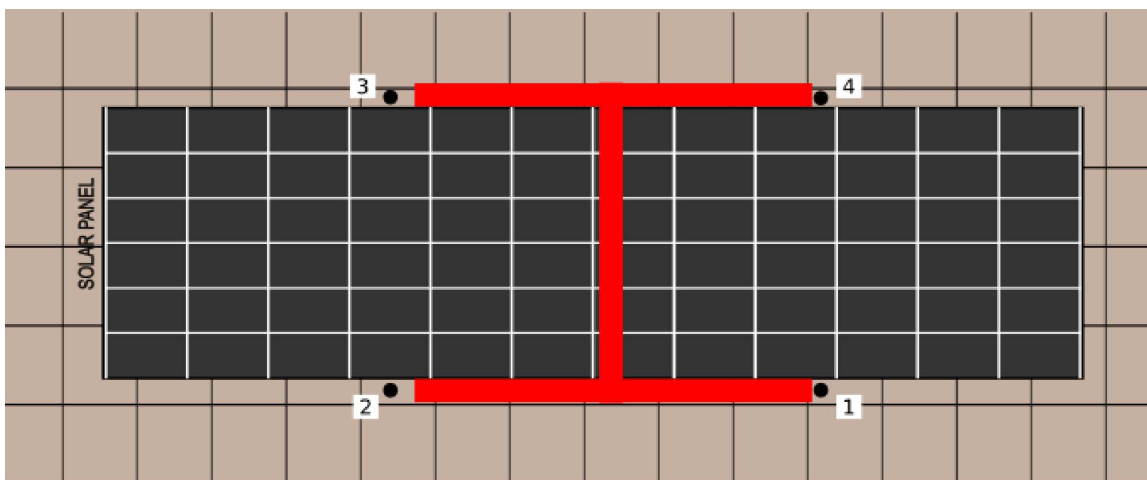
### VISUAL DEFORMATION LOCATION SKETCH

● Bracket/Panel Gap Spacing Check

| CLIENT | | CLIENT PROJECT REF. NO. | | | CLIENT ORDER NO. | |
|---|---|---|---|---|---|--|
| The test specimen consisted of the solar panels, brackets, railing and the simulation tile roof. The bracket locations were visually examined for gap spacing to ensure there was no contact between the roof tile and the bracket. At each location a sheet of paper was slid beneath the bracket to verify open spacing between the tile and bottom of the bracket. After the initial inspection the compressive load was applied using plastic jugs filled with water. Four jugs were randomly selected and weighted to determine an average weight per jug of 45.31 lbf. Load was applied evenly by even distribuion of 11 water jugs across the test specimen. After the first load was applied, the gaps between the brackets and tile roof were examined. Additional load was applied with 17 jugs and then 18 jugs. At 18 jugs the gap between the bracket and the roof was too tight to fit the sheet of paper underneath due to geometry of the tile roof but the bracket was not in contact with the roof. After the final load test, all the weights were removed and the test specimen was visually examined for any permanent damage or deformaton. | | | | | | |

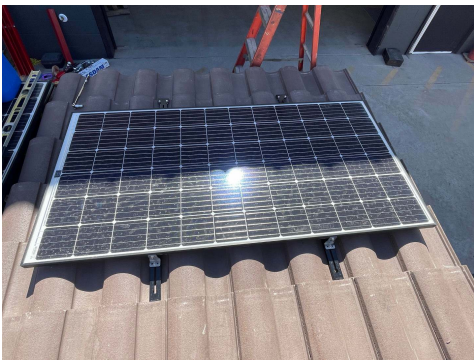
**PHOTO 1:** Overview of solar panel and tile roof deck - before tests

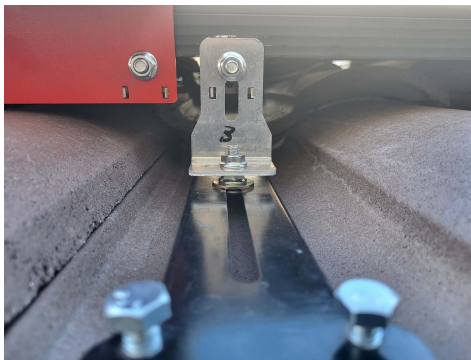
**PHOTO 2:** Typical Bracket - before tests

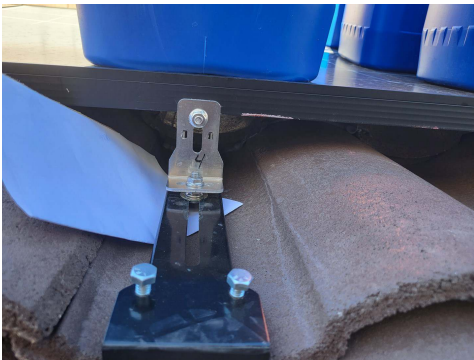
**PHOTO 4:** Load 1 - Bracket under load

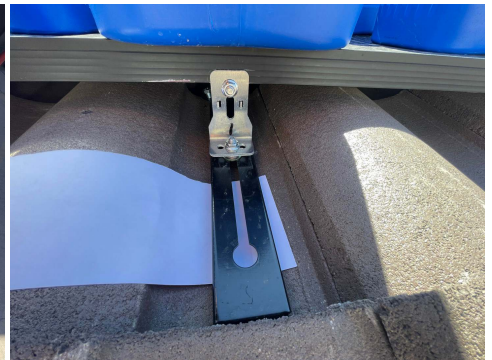
**PHOTO 6:** Load 2 - Bracket under load

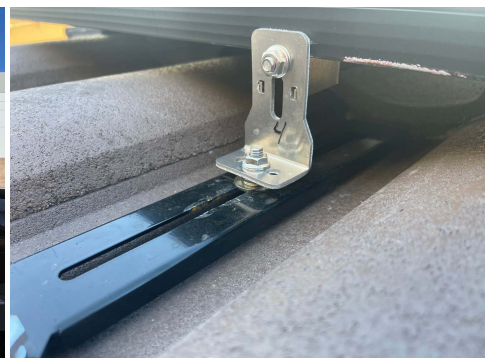
**PHOTO 9:** Unloaded Bracket - after tests

Note: Bracket photos are typical of all locations

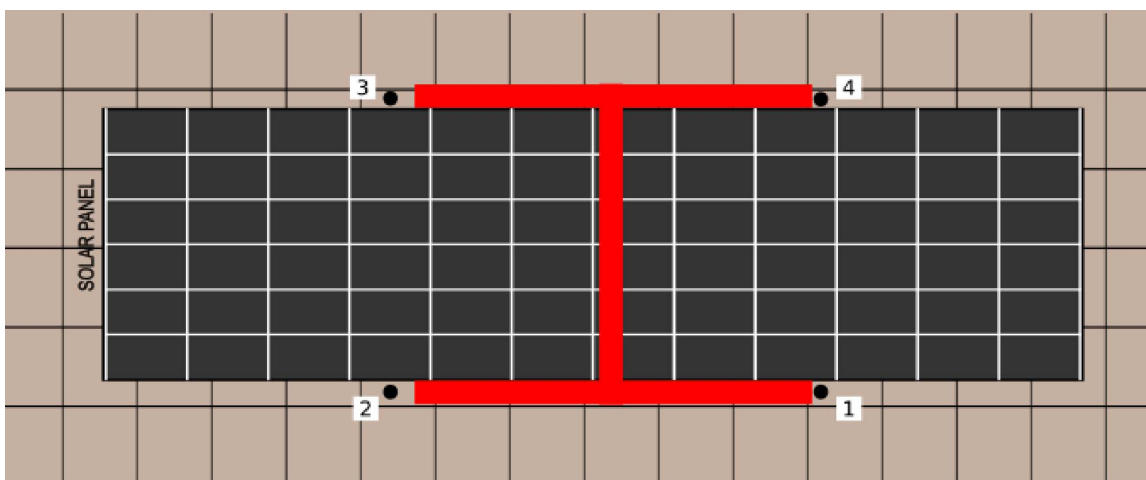
### SKETCH

● Bracket/Panel Gap Spacing Check

| The test specimen consisted of the solar panels, brackets, railings and the simulation roof. The test specimen was initially visually examined for any damage or permanent deformation prior to testing. The horizontal load was applied after initial inspection was completed. The horizontal load was applied using a chain hoist and a digital dynamometer. The load was applied at the center of the crossbeam. The crossbeam was attached to the solar panel brackets. After the load was applied the specimen was examined for any damages or deformation while under load. After examination the horizontal load was released and the test specimen was examined again for any permanent deformation or damage. | | | | | | |

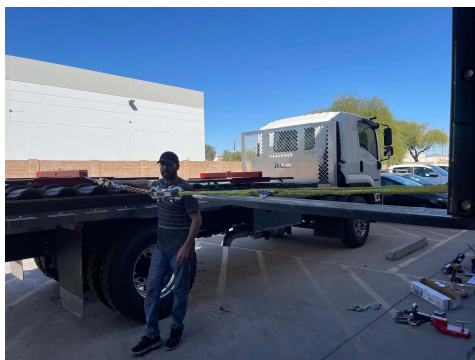
**PHOTO 3:** Test setup for horizontal pull load

The horizontal load test was conducted using a Weightronic Digital Dynamometer (Model OCS-Y) and chain hoist. A horizontal load of at least 500 lbf was applied at the center of the crossbeam that was attached to the panel brackets. The test specimen held the load and no damage or permanent deformation was noted as shown in the test observations table shown below.

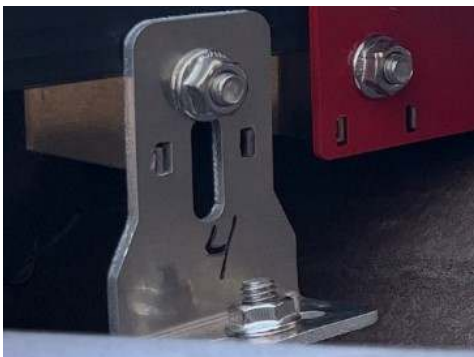
**PHOTO 5:** Bracket under load

| After removal of test load all brackets returned to original position with no permanent deformation noted. | | | | | | |

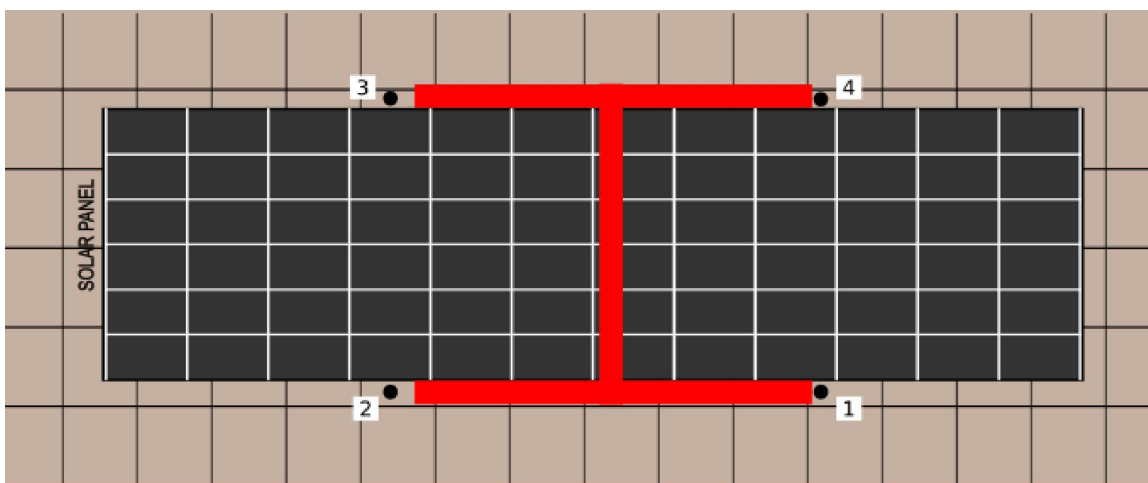
### SKETCH

● Bracket/Panel Gap Spacing Check

| The test specimen consisted of the solar panels, brackets, railing, and the simulation tile roof. The test specimen was visually examined for any damage or permanent deformation prior to testing. The uplift tensile pull load was applied after initial inspection was completed. Uplift load was applied using a chain hoist and a digital dynamometer. The load was applied at the center point of the cross beam. The cross beam was attached to the solar panel brackets. After the load was applied the specimen was examined for any damages or deformation. After examination the vertical load was released and the test specimen was examined again for any permanent deformation. | | | | | | |

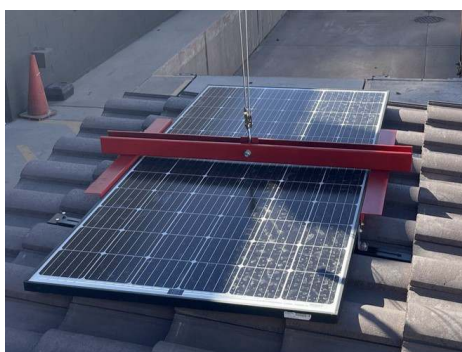
**PHOTO 2:** Overview of tensile test setup and connection

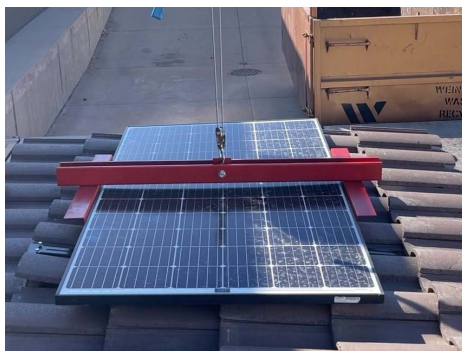
**PHOTO 5:** Test specimen while under tensile load

The uplift load test was conducted using a Weightronic Digital Dynamometer (Model OCS-Y) and chain hoist. An uplift load of 710 lbf, equivalent to a 33.08 psf uplift force evenly applied to the solar panels, was applied at the center of the crossbeam that was attached to the four panel brackets. The test specimen held the load and no damage or permanent deformation of the test brackets was noted as shown in the test observations table shown below.

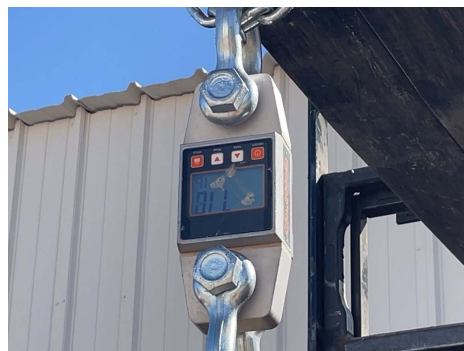
**PHOTO 6:** Dynamometer scale under load

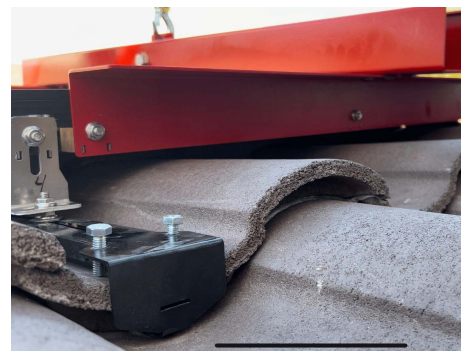
**PHOTO 7:** Bracket under test load

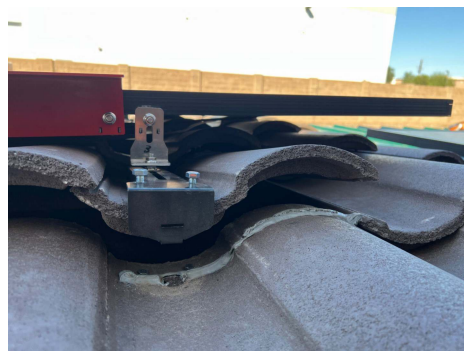
**PHOTO 9:** Bracket unloaded after test - roof tile bond pulled apart.

| At Bracket No. 3, the tile roof shingle separated at the glue bond from the shingle underneath. | | | | | | |
