| | PROJECT<br>IntegraRack | | | | |
| | TITLE<br>IR-00MBDB / IR-W5MDB Solar Racking System | | | | |

# PRELIMINARY LABORATORY TEST REPORT

Subject: Witness of Wind Tunnel Testing on IntegraRack Products at the George E Boeing Aeronautics Department (Kirsten Wind Tunnel) at the University of Washington

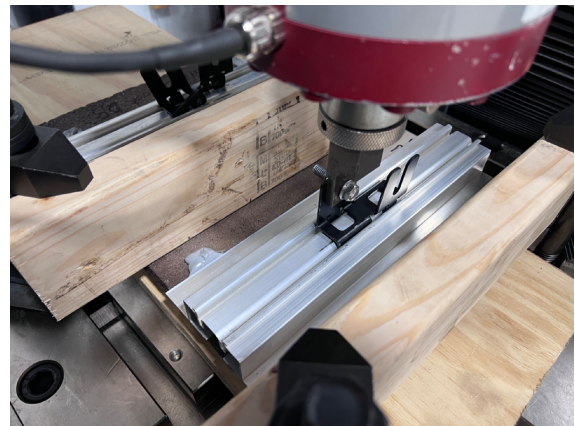
**Photo 3:** Tension test, setup #1

| CLIENT | | PROJECT/TEST DESCRIPTION | | | | CLIENT ORDER NO. |
|---|---|---|---|---|---|---|
| 1 | Multiballast DB bonded to tile shingle #1 with H bracket (photo 3) | 0.602 | 594 | 9.1 | N/A | Test stopped when H-Module bracket slipped out of Multiballast DB base. Minor deformation was noted in the "H" bracket @ ~ 450 lbf |

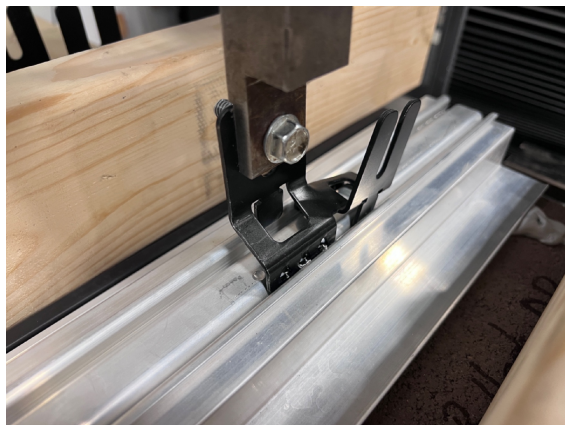
**Photo 4:** Tension test, setup #2

| CLIENT | | PROJECT/TEST DESCRIPTION | | | | CLIENT ORDER NO. |
|---|---|---|---|---|---|---|
| 2 | Multiballast DB bonded to tile shingle #2 with H bracket (photo 4) | 0.592 | 557 | 9.6 | N/A | Test stopped when H-Module bracket slipped out of Multiballast DB base Minor deformation was noted in the "H" bracket @ ~ 430 lbf |

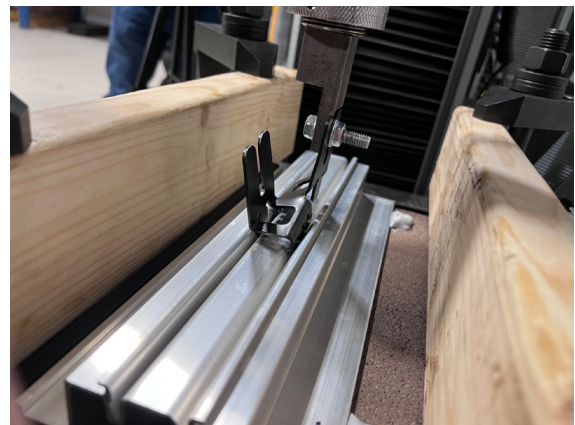
**Photo 5:** "H" bracket deformed and slipped out of Multiballast DB base test #1

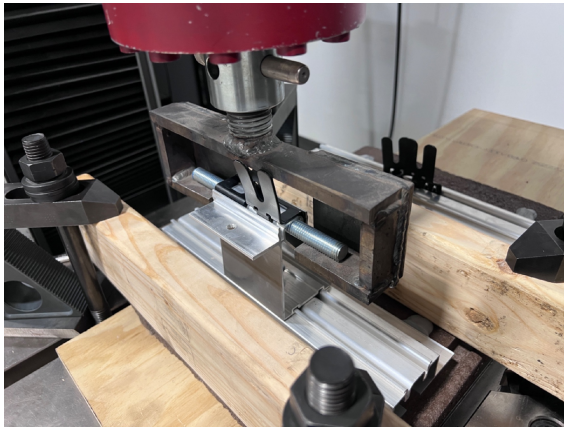
**Photo 6:** "H" bracket deformed and slipped out of Multiballast DB base test #2

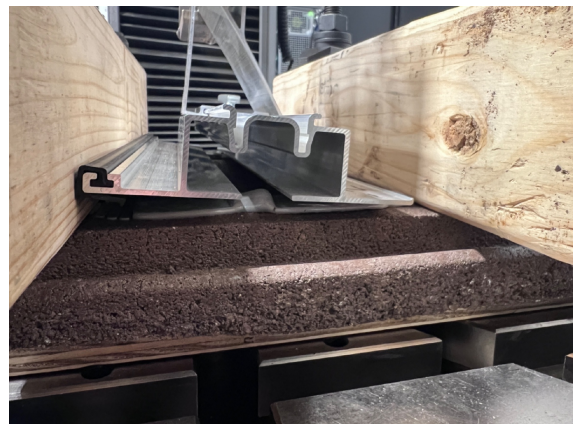
**Photo 12:** Tension test #4 adhesive failure, aluminum to adhesive

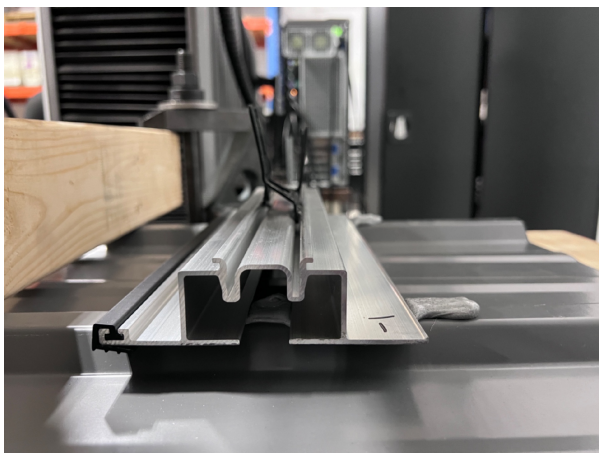
**Photo 5:** Tension test #1 "H" bracket slipped out

| CLIENT | | PROJECT/TEST DESCRIPTION | | | | CLIENT ORDER NO. |
|---|---|---|---|---|---|---|
| 1 | Multiballast DB bonded to metal roof #1 with H-module (Photo 3) | 0.782 | 520 | 5.1 | N/A | @ ~410 lbf deformation was noted in the "H" bracket, and @ ~520 lbf test stopped when "H" bracket slipped out of aluminum extrusion. |

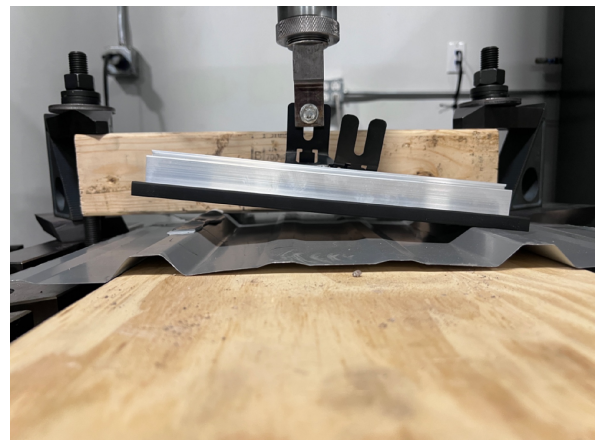
**Photo 6:** Tension test #2 adhesive failure, aluminum to adhesive interface

| CLIENT | | PROJECT/TEST DESCRIPTION | | | | CLIENT ORDER NO. |
|---|---|---|---|---|---|---|
| 2 | Multiballast DB bonded to metal roof #2 with H-module (Photo 4) | 0.652 | 510 | 5.1 | 100 | @ ~430 lbf deformation was noted in the "H" bracket, and @ ~520 lbf test stopped when 2 corners of the Multiballast DB de-bonded, aluminum to elastomeric sealant |

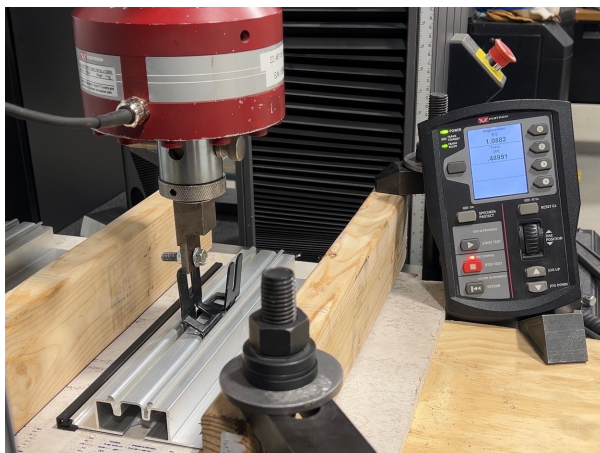
**Photo 5:** Bolt slipping out of "H" bracket

| CLIENT | | PROJECT/TEST DESCRIPTION | | | | CLIENT ORDER NO. |
|---|---|---|---|---|---|---|
| 1 | Multiballast DB bonded to cement board #1 with H bracket (Photo 3) | 0.622 | 525 | 8.5 | N/A | @ ~450 lbf the “H” bracket started to deform and @ ~519 lbf the bolt clamping the “H” bracket to the UTM started slipping |

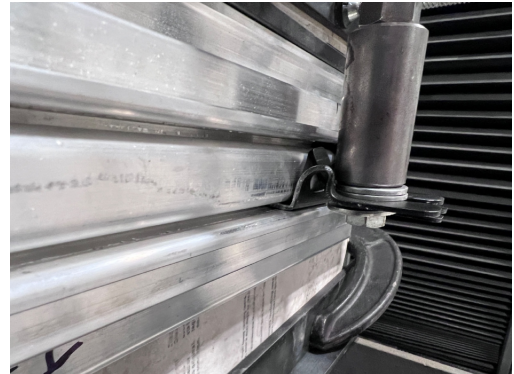
**Photo 10:** "H" bracket deformation post test

| CLIENT | | PROJECT/TEST DESCRIPTION | | | | CLIENT ORDER NO. |
|---|---|---|---|---|---|---|
| 1 | Multiballast DB bonded to cement board #2 with tower bracket (Photo 8) | 0.517 | | 678 | @ ~450 lbf the “H” bracket tab pulled out and the teeth sections engaged, load increased up to max load then deformation started.<br><br>@ 0.83 in. Displacement is 1 <sup>st</sup> adhesive drop. 2 <sup>nd</sup> adhesive drop triggered end of test, aluminum to adhesive bond | |

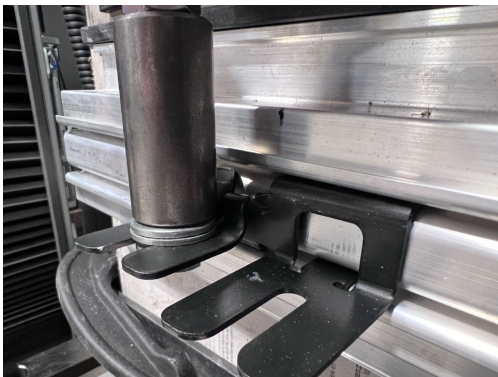
**Photo 11:** "H" bracket deformation post test

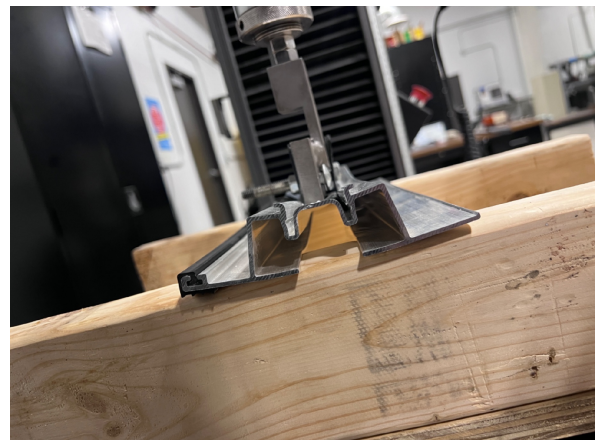
**Photo 6:** Deformation post testing

| CLIENT | | PROJECT/TEST DESCRIPTION | | CLIENT ORDER NO. | | |
|---|---|---|---|---|--|--|
| 1 | Multiballast DB base with H-module bracket | 0.888 | 2,653 | Test stopped due to permanent deformation to the Multiballast DB base. | | |

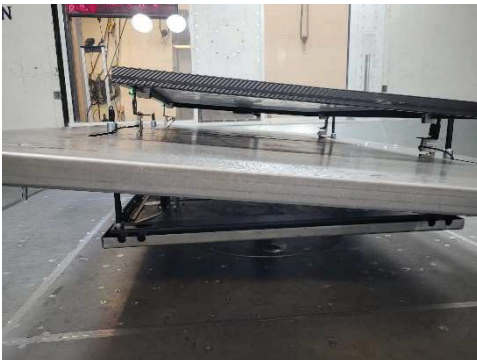
Figure 13: Setup after Run 2, 109 mph winds.  
No damages or loose hardware noted

to any bracket during or after the test runs and all hardware was found to be secure upon completion of each test (See Figures 11-13).
