1 1 1 1 1 1 1 1 1 1	In	_	DB Solar	Racking Sys	tem
APPROVED	SIZE	CODE	DWG NO		REV
CHECKED	В				
DRAWN Paul Budge 9/25/2025	SCA	LE	WEIGHT	SHEET 1/3

Subject: Witness of Wind Tunnel Testing on IntegraRack Products at the George E Boeing Aeronautics Department (Kirsten Wind Tunnel) at the University of Washington

Test Summary: Multiballast DB to Tile Shingle

Test Summary: Multiballast DB to Metal Roof

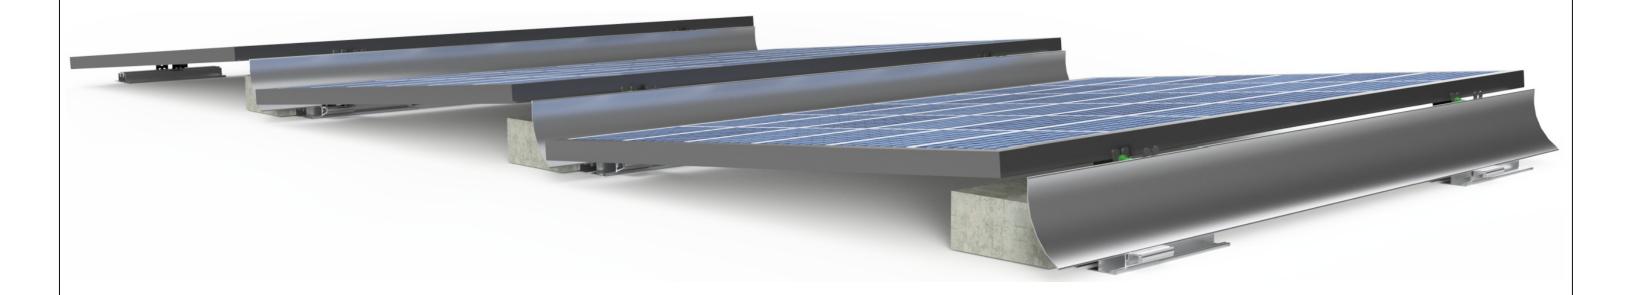
*Data extrapolated from 11-24 Boeing Wind Tunnel testing and mechanical BallastRack hydraulic load testing.

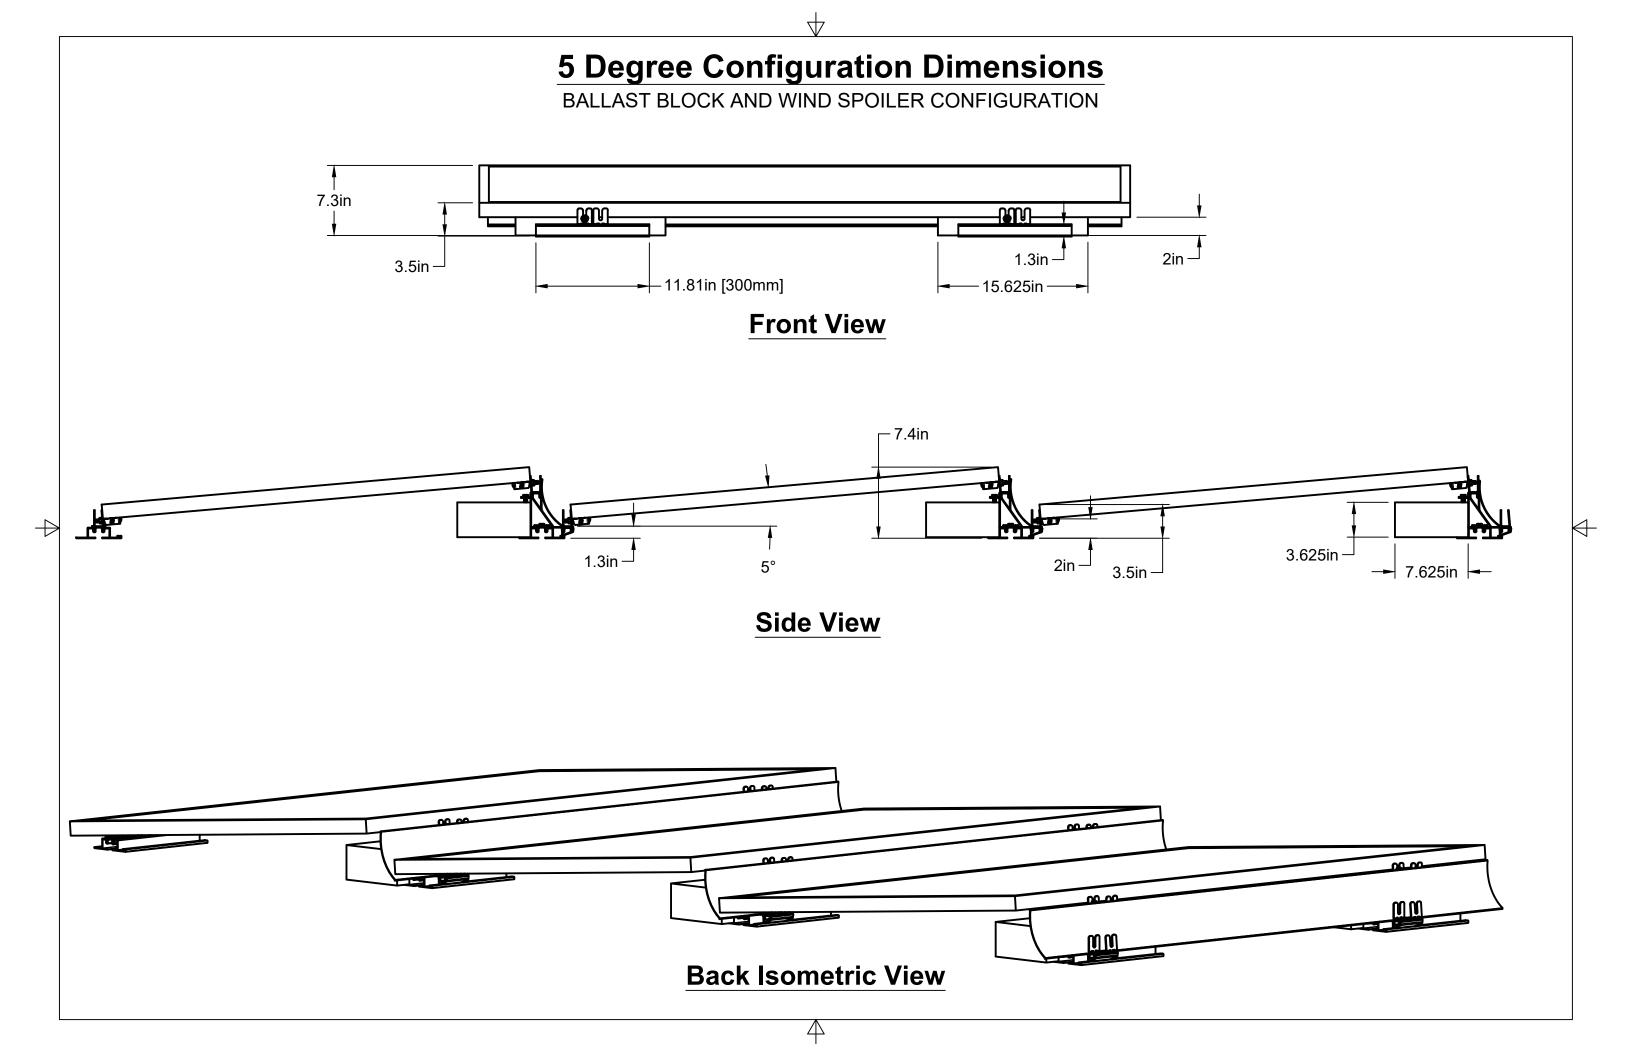
- Designed for ballasted deployment of solar modules on flat roofs or flat ground scenarios.
- Utilizes standard 32lb 4in x 8in x16in CMU cinder blocks.
- Roof material slip sheets (9in x 6in) recommended underneath each base.

IR-05MBDB	Solar Racking Syster	n					
	Module size up to 24 sqft	Module size up to 34 sqft					
Maximum Snow Load							
	100psf	65psf					
Maximum Wind Speed (Ballast Block and Wind Spoiler REQUIRE							
2 Base Mounts per panel 20lb CMU Blocks	100mph	80mph					
3 Base Mounts per panel 20lb CMU Blocks	120mph	100mph					
2 Base Mounts per panel 32lb CMU Blocks	140mph	100mph					
3 Base Mounts per panel 32lb CMU Blocks	160mph	120mph

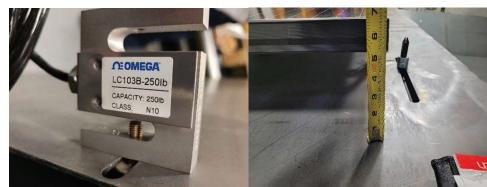
Figure 5: Load Cell Model used for tests

Figure 4: Bracket at back edge LC5-3, LC5-4

Test Runs 2 through 5 included rotating the test setup from 0 to 110 degrees while KWT instrumentation recorded test data. Wind speed was increased until limitations of KWT instrumentation prevented it from being increased further. Four load cells, Omega model LC103B-250 lb Class N10, were installed between the IntegraRack bracket and the roof surface to monitor and record loads applied to the brackets throughout testing (See Figures 5-10). The load cells were labeled LC0-1, LC0-2, LC5-3, and LC5-4 with LC0 being installed at the leading edge and LC5 being installed at the back edge.
