Real Property of the Control of the	TITLI IR	tegraR	DB Solar R	acking Sys	tem
APPROVED	SIZE	CODE	DWG NO		REV
CHECKED	В				
DRAWN Paul Budge 9/25/2025	SCA	LE	WEIGHT	SHEET 1/3

IR-0BMBDB Solar Racking System								
	Module size up to 24 sqft	Module size up to 34 sqft						
Maximum Snow Load								
	100psf	65psf						
Maximum Wind Speed (Ballast Block)								
2 Base Mounts per panel 20lb CMU Blocks	120mph	100mph						
3 Base Mounts per panel 20lb CMU Blocks	150mph	120mph						
2 Base Mounts per panel 32lb CMU Blocks	160mph	130mph						
3 Base Mounts per panel 32lb CMU Blocks	180mph	140mph

Subject: Witness of Wind Tunnel Testing on IntegraRack Products at the George E Boeing Aeronautics Department (Kirsten Wind Tunnel) at the University of Washington

Test Summary: Multiballast DB to Tile Shingle

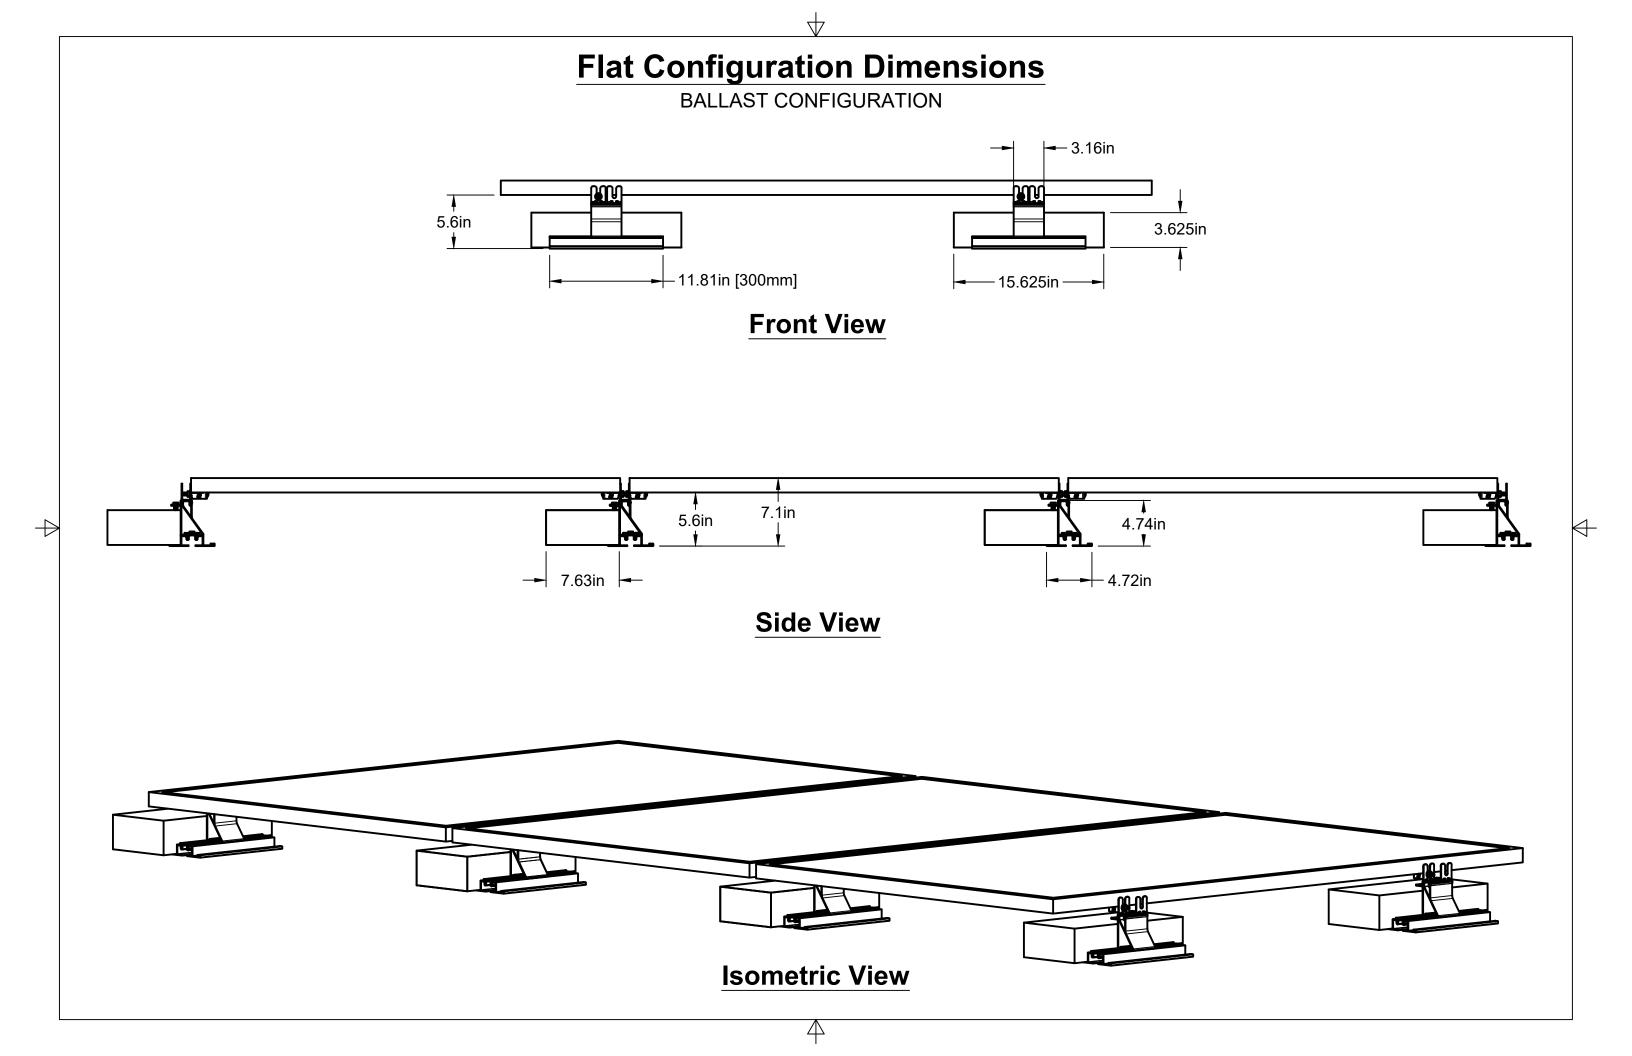
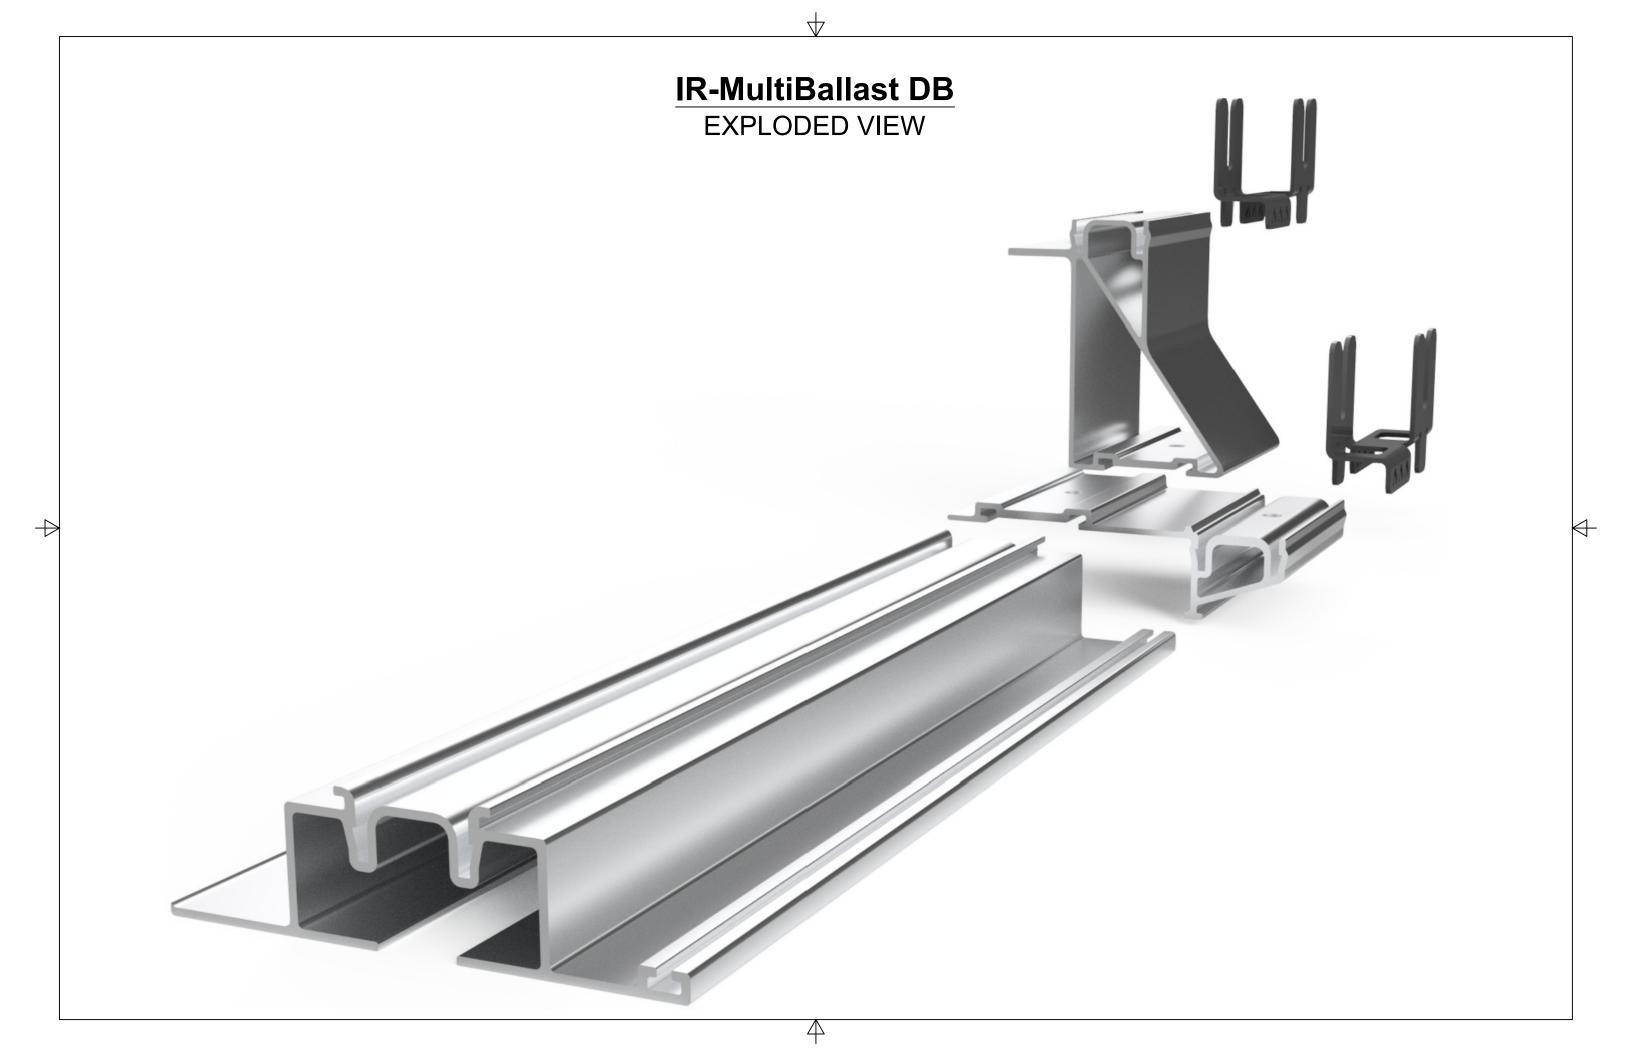
- Designed for ballasted deployment of solar modules on flat roofs or flat ground scenarios.
- Utilizes standard 32lb 4in x 8in x16in CMU cinder blocks.
- Roof material slip sheets (9in x 6in) recommended underneath each base.

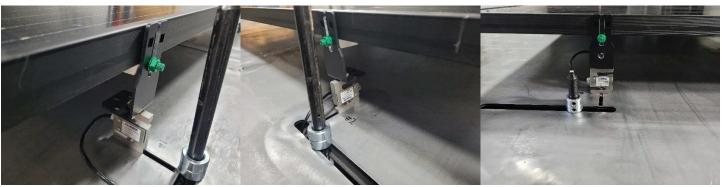
Figure 7: LC0-1 Location

Figure 8: LC0-2 Location

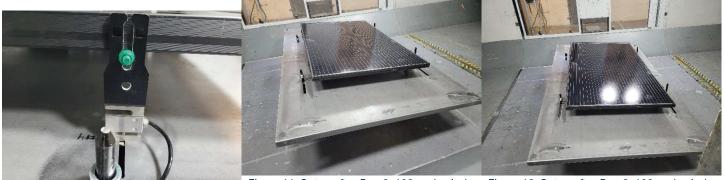
Figure 9: LC5-3 Location

Figure 10: LC5-4 Location

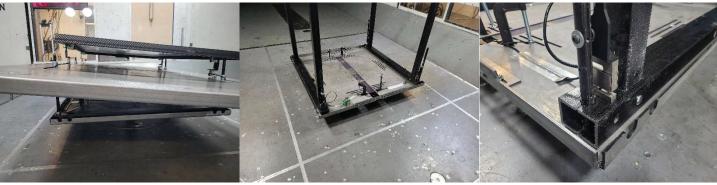
Figure 11: Setup after Run 2, 109 mph winds. Figure 12: Setup after Run 2, 109 mph winds. No damages or loose hardware noted

Figure 13: Setup after Run 2, 109 mph winds. No damages or loose hardware noted

The maximum load at a bracket recorded during Test Runs 2 and 3 was 75.015 lbf at a wind speed of 157.67 MPH when the panel was at a rotation point of 60 degrees. No damage or deformation was noted

to any bracket during or after the test runs and all hardware was found to be secure upon completion of each test (See Figures 11-13).

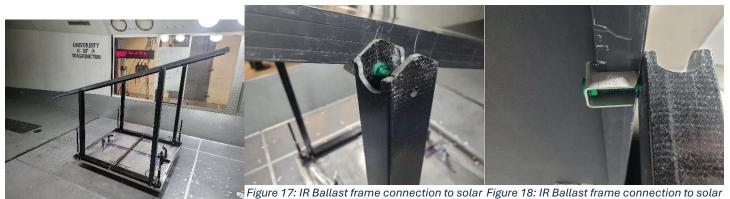
Figure 14: Setup for Run 6 with IR Ballast Frame

Figure 15: Load cell location at leading edge, LC0-1 & LC0-2

Test Runs 6 through 8 were performed on the IR Ballast Racks (See Figures 14-32). The simulated roof structure was removed and the frames and panel were mounted directly to the KWT test platform. These runs were performed at a set angle with no platform rotation during the test run. Two load cells were used for the test setups and were mounted at the brackets at the leading edge of the test platform at the wind intake side.

Run 6 was performed on the IR18C with the solar panel at an approximate 18 degree angle (Figures 24-25). The maximum load at a bracket recorded during Test Run 6 was 168.59 lbf at a wind speed of 101.59 MPH. Runs 7 and 8 were performed on the IR30C with the solar panel at a 30 degree angle (Figures 30-32) with Run 7 having the solar panel mounted and aligned with the wind direction to produce maximum forces on the frame and Run 8 being run in an orientation 90 degrees offset from Run 7. The maximum load at a bracket was during Test Run 7 and was 183.38 lbf at a wind speed of 81.138 MPH. Run 7 was stopped when the drag limit of the KWT test apparatus was reached. The solar frame experienced shaking under wind load but no damage was found to any part and all bolts were found to still be tight and in place after the test run. Run 8 was pitch limited by the KWT test apparatus. Similar to Run 7 the frame and solar panel had experienced shaking under load but no damage to the frame or panel was noted and all bolts and connections remained tight.

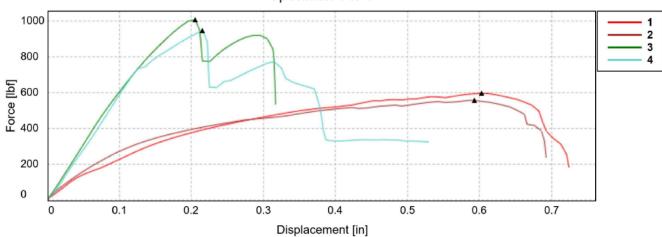
Figure 1: Tension Force vs Displacement test graph

The H-module bracket was installed on the Multiballast DB base mount using the designed slide rails for installation. Using only 1 of the 2 mounting holes on the H-module the UTM was bolted to the H-module bracket (photos 3 and 4) applied a tensile force pulling straight up on the bracket at a test speed of 6 in./min. This led to a failure of the H-module, the interlocking tabs started slipping out of the Multiballast DB base. The H-module bracket was pulled off and the riser bracket was put on (photos 7 and 8) allowing the tensile force to be applied over a more distributed area, with more engagement to the Multiballast DB base and this allowed a high enough load to witness an adhesive failure.

4	Multiballast DB bonded to tile shingle #1 with Riser bracket (photo 9)	0.215	947	9.1	104	3 corners of the Multiballast DB de-bonded, aluminum to elastomeric sealant. The first corner popped @ ~ 919 lbf, the 2 nd corner @ ~ 740 lbf and the 3 rd corner @ ~ 336 lbf				
		COMPR	ESSION LO	DAD TEST	T DATA					
Test No.	Test Specimen	Displacem Maximum L			um Load n.)	Observations				
1	Multiballast DB bonded to tile shingle #2 with tower bracket (photo 15)	0.272	2	7	'29	Test automatically stopped due to load drop when the tile cracked @ 729 lbf				
2	Multiballast DB bonded to tile shingle #2 with tower bracket (photo 16)	0.530)	1,353		1,353		1,353		Initial minor deformation was noted starting @ ~ 850 lbf, test continued until major deformation was witnessed load drop after hitting a max load of 1,353 lbf

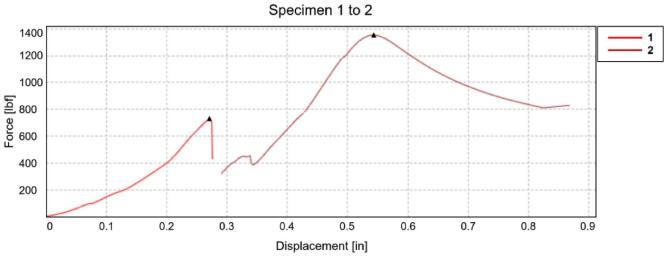
Figure 2: Compression Force vs Displacement test graph

A compression test was also run on this specimen. All table clamps were removed, a fixture was bolted through the H-module (photos 13 and 14) allowing a compressive force to be applied through the H-module, riser, Multiballast DB base, and into the tile substrate at a test speed of 2 in./min. The first cycle load was applied and the test was stopped due to the tile cracking. Test was continued from that point and a compressive force was applied until major permanent deformation was noticed in the H-module and riser bracket.

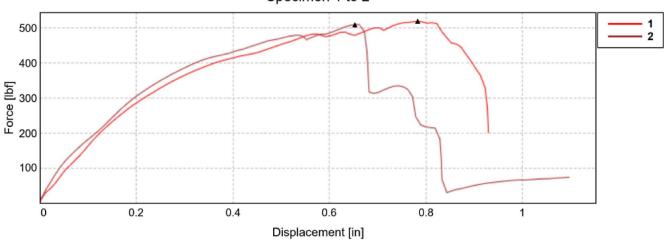
Figure 1: Tensile Force vs Displacement test graph

The H-module bracket was installed on the Multiballast DB base mount using the designed slide rails for installation. Using only 1 of the 2 mounting holes on the H-module the UTM was bolted to the H-module bracket (photos 3 & 4) and applied a tensile force pulling straight up on the bracket at a test speed of 6 in./min.

TENSION LOAD TEST DATA							
Test No.	Test Specimen	Displacement at Maximum Load (in.)	Maximum Load (lbf)	Glue Contact Area (sq. in.)	Adhesive Strength (lbf/in)	Observations		
1	Multiballast DB bonded to metal roof #1 with H-module (Photo 3)	0.782	520	5.1	N/A	@ ~410 lbf deformation was noted in the "H" bracket, and @ ~520 lbf test stopped when "H" bracket slipped out of aluminum extrusion.		
2	Multiballast DB bonded to metal roof #2 with H-module (Photo 4)	0.652	510	5.1	100	@ ~430 lbf deformation was noted in the "H" bracket, and @ ~520 lbf test stopped when 2 corners of the Multiballast DB de-bonded, aluminum to elastomeric sealant

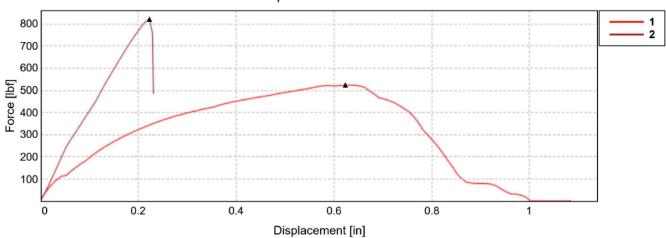
Figure 1: Tensile Force vs Displacement test graph

The H-module bracket was installed on the Multiballast DB base mount using the designed slide rails for installation. Using only 1 of the 2 mounting holes on the H-module the UTM was bolted to the H-module bracket and applied an upwards tensile force on the bracket at a test speed of 6 in./min. This led to a failure of the H-module, bolted connection between the UTM and the H-module bracket started slipping (photos 4 & 5). The H-module was then pulled off and the riser bracket was put on, allowing the tensile force to be distributed over more area and with more engagement to the Multiballast DB base mount. This allowed a high enough load to witness an adhesive failure (photos 6 & 7).

1	Multiballast DB bonded to cement board #2 with tower bracket (Photo 8)	0.517	7	6	78	 @ ~450 lbf the "H" bracket tab pulled out and the teeth sections engaged, load increased up to max load then deformation started. @ 0.83 in. Displacement is 1st adhesive drop. 2nd adhesive drop triggered end of test, aluminum to adhesive bond

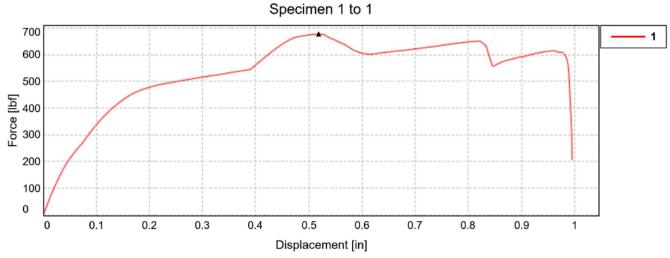
Figure 2: Lateral Load "Shear Racking" Compressive Force vs Displacement test graph

A shear racking "lateral load" test was also run on this specimen. A test fixture (Photo 8) was used that allowed us to clamp the test specimen at a 90-degree angle to the UTM crosshead. The specimen was clamped to the fixture using c-clamps and some flat steel to distribute the clamping force across the whole board (photo 9). Using only 1 of the 2 mounting holes on the H-module, the UTM was bolted to the H-module bracket, and a downward compressive force was applied at a test speed of 1 in./min on the side of the side of the H-module bracket until an adhesive failure was witnessed (photo 12).

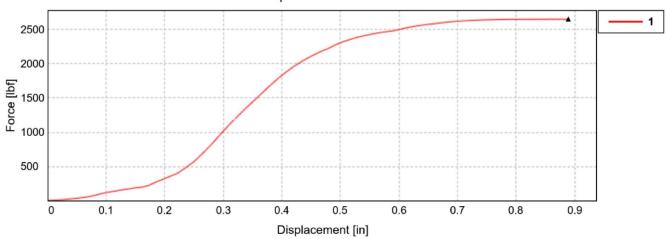
Figure 1: Compressive Force vs Displacement test graph

both of the mounting holes on the H-module the universal test machine (UTM) was bolted to the H-module bracket applied a compression force pushing straight down on the bracket H-module bracket and the Multiballast DB base at a test speed of 2 in./min.

COMPRESSION LOAD TEST DATA				
Test No.	Test Specimen	Displacement at Maximum Load (lbf)	Maximum Load (in.)	Observations
1	Multiballast DB base with H- module bracket	0.888	2,653	Test stopped due to permanent deformation to the Multiballast DB base.
